Test Report No. CANMLC2305708701 Date: 26 Apr 2023 Page 1 of 3

Sample Name : POLYSTYRENE(EPS) SANDWICH PANEL

Test Method: With reference to NIOSH 9000:2015 / ISO 22262-1:2012, Analysis was performed by XRD / PLM.

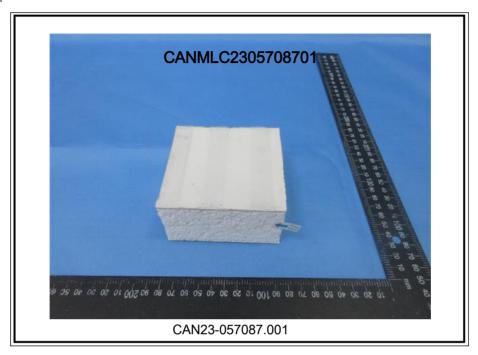
Sample photo:

Specimen No. SGS Sample ID Description
SN1 CAN23-057087.001 White material
